Eddon Boat Park Minutes
City of Gig Harbor

August 2, 2005

Steve Misiurak and Bud Whitaker did an inspection at the site this morning. They had a slide show showing the results.

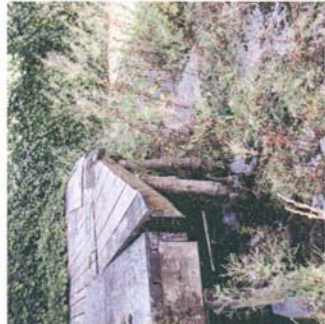
Wild Birds Unlimited building: Roofing is beyond serviceable life, replacement needed. Deck and exterior stairs are in desrepair and are non-conforming. Repairs will require upgrades per code. Rear deck joists are over-spanned, untreated and support posts are deficient. Unsafe existing conditions. A portion of the rear deck is unsafe, unsupported and non-conforming. The electrical system is out dated and needs service upgrade to current standards. Attic venting is inadequate. The exterior siding and trim is at end of serviceable life. The building is considered unsafe. Estimated demolition cost is \$12,700.00.

of rear deck is unsafe
ported and non-conforming
to current standards.

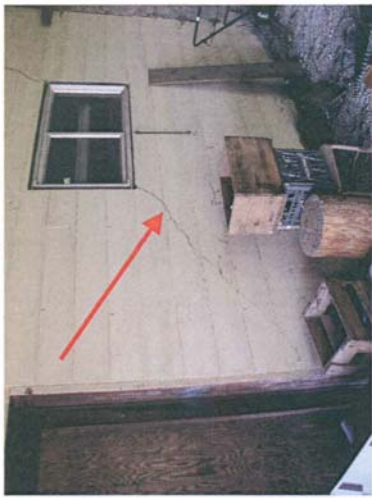
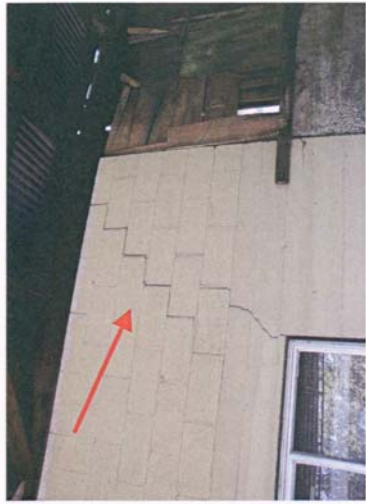
ra's Box

Pandora's Box: Cement masonry exterior walls are un-reinforced, significant cracks and separations are visible in the exterior walls. The building is considered unsafe. The rear roof framing is over-spanned. The roof ledger is not bolted to the structure and the roof rafters are toe-nailed to the ledger. Estimated demolition cost is \$9,300.00, which includes foundation and asphalt removal.

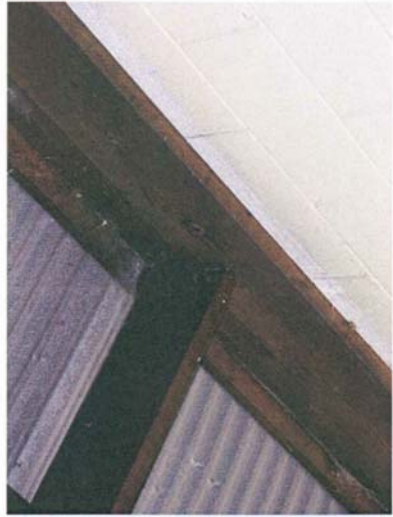
spanned.

-Roof ledger is not bolted to structure.

-Roof rafters are toe-nailed to ledger

**\$9,300.00 includes
cutting and removal**

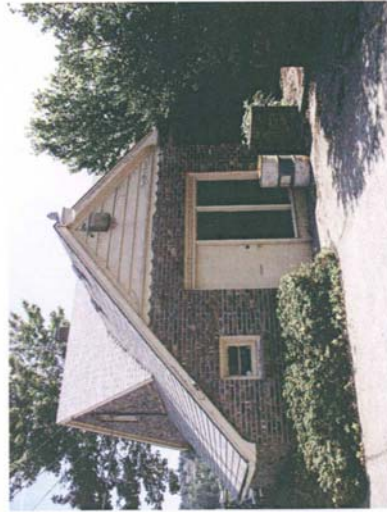
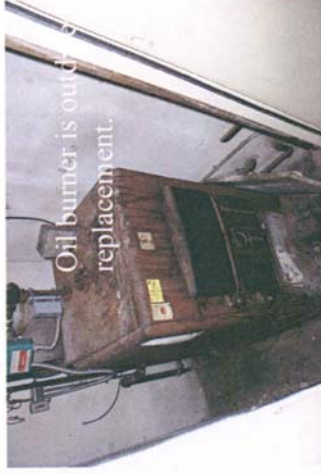
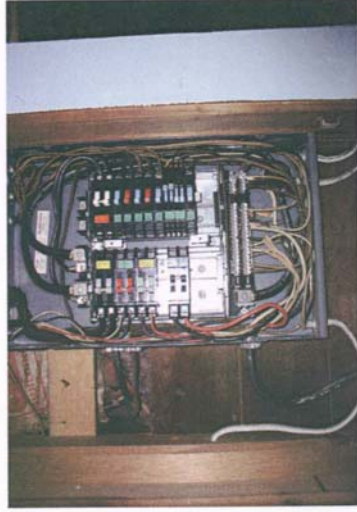
Tudor House

Tudor House: The brick veneer is failing, repairs or replacement is needed. The interior plumbing and fixtures need replacement. The roof framing is sagging, this is a structural problem. The electrical system is outdated and unsafe and need replacement. Possible asbestos and lead abatement. The insulation is inadequate. Estimated demolition cost is \$9,400.00 includes foundation. It was suggested and discussed by all who attended to demoish all buildings, clear, grade and hydroseed site.

- Brick veneer is failing/ repairs, replacement needed.
- Interior plumbing and fixtures need replacement.
- Roof framing is sagging (structural)
- Electrical system is unsafe/outdated and needs replacement.
- Possible asbestos and lead abatement
- Insulation is inadequate.

Estimated demolition \$9,400.00 includes foundation
